NASA/CR-2017-219668

# Hybrid Wing Body Multi-Bay Test Article Analysis and Assembly Final Report

*Alexander Velicki, Krishna Hoffman, Kim A. Linton, Jaime Baraja,  
Hsi-Yung T. Wu and Patrick Thrash  
The Boeing Company, Huntington Beach, California*

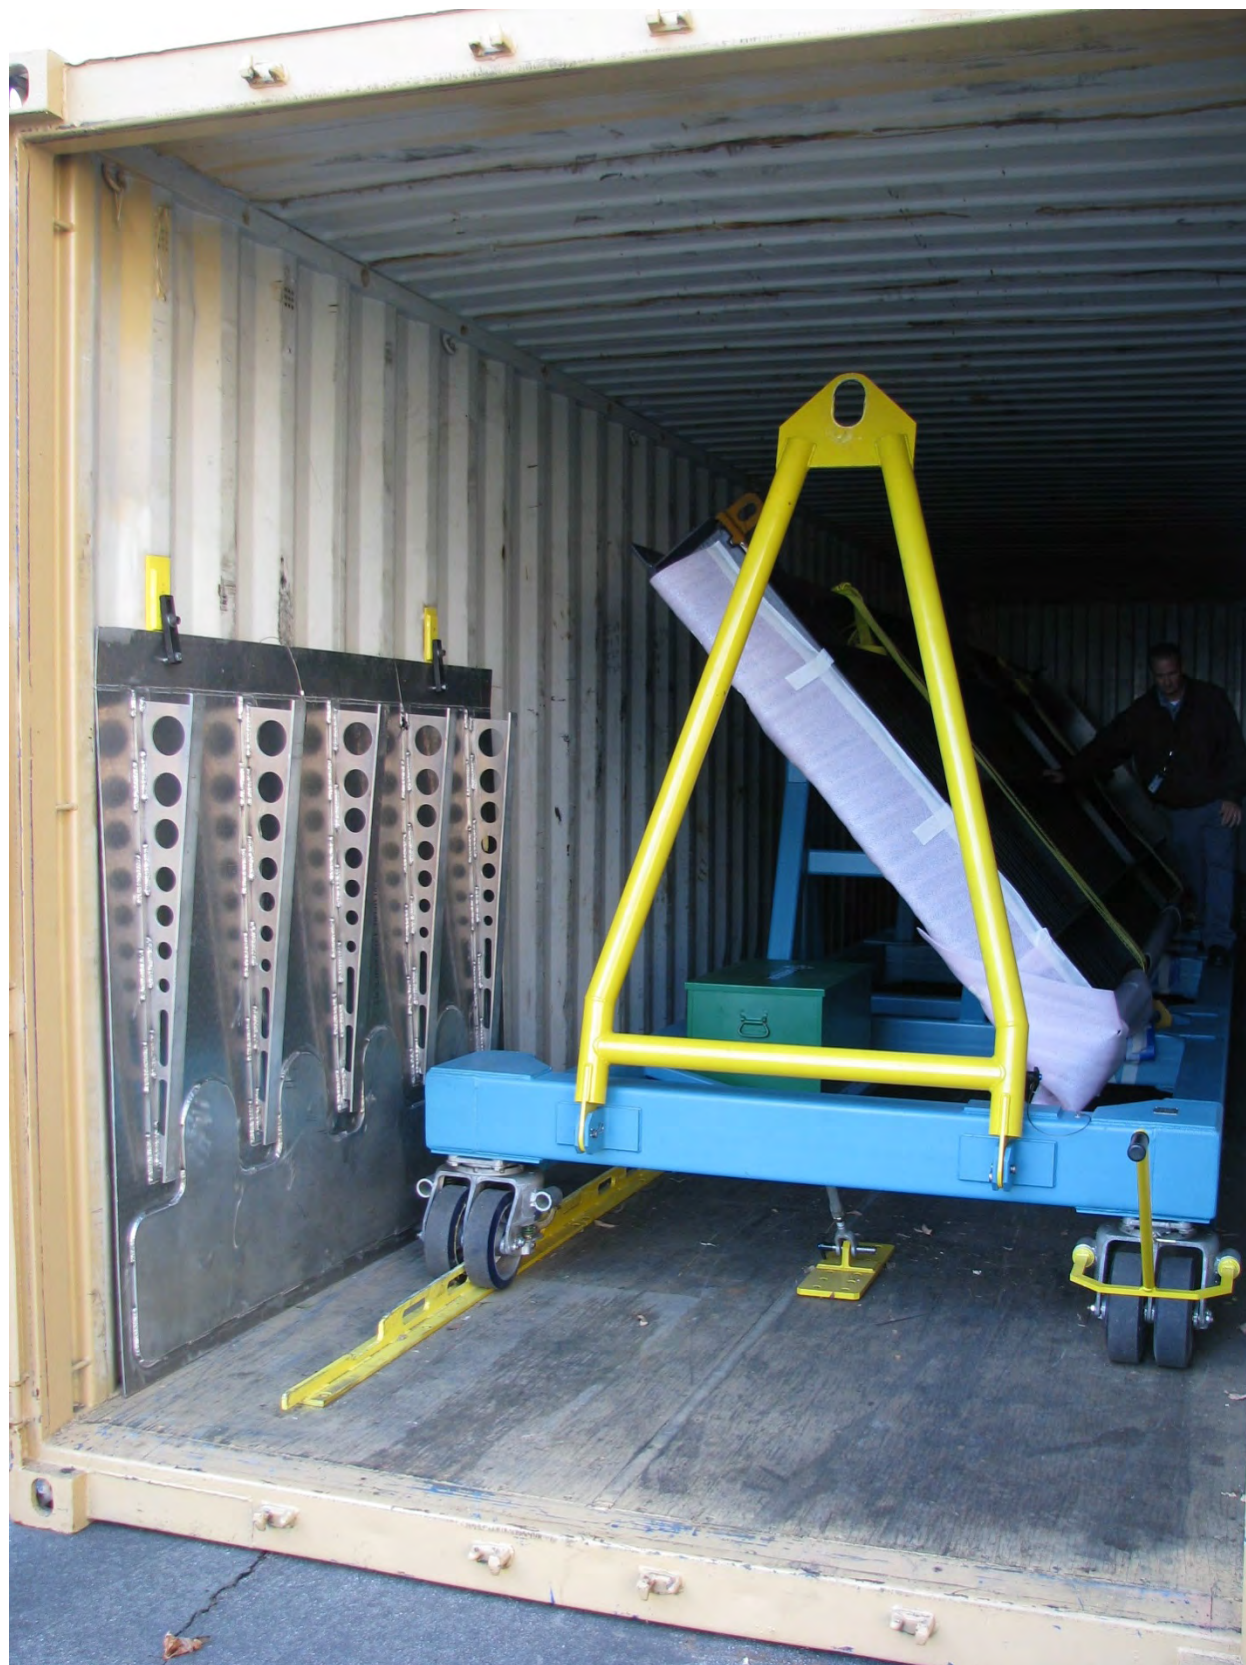
**Figure 6-30. Panel on Transportation Dolly Loaded Inside SEAVAN Container**

Panels were manufactured with excess material around the perimeter and along the top of the bulkhead/rib cap webs. The final profile of the skin and caps was achieved by machining at an outside supplier. To accomplish this, a cured panel was placed onto a large transport dolly (Figure 6-29), the dolly with panel was loaded inside a SEAVAN container (Figure 6-30), and the panel was then transported by truck to the machining supplier's facility.

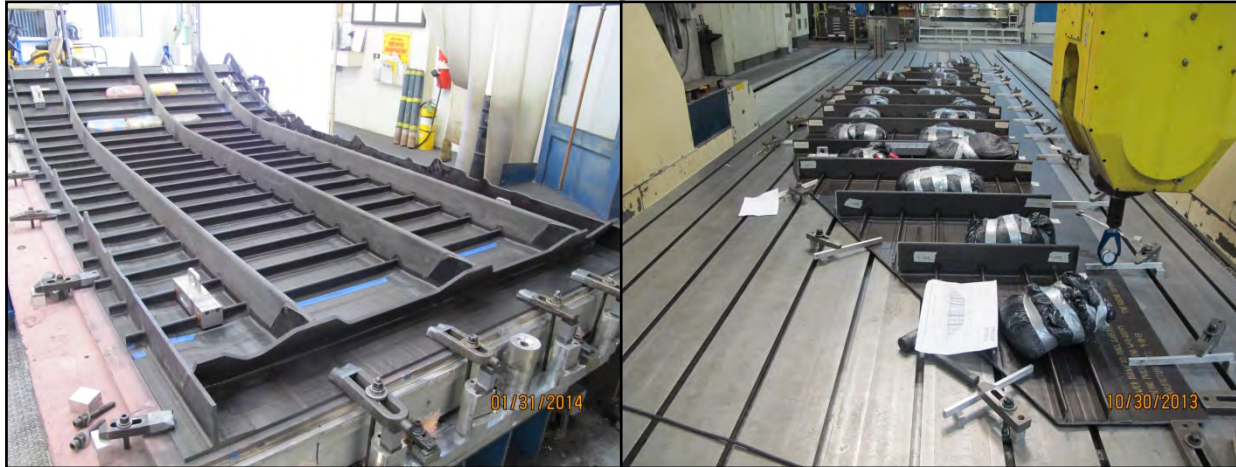
**Figure 6-31. Periphery Machining of Lower Bulkhead Panel (left) and Side Keel Panel (right)**

The panels were installed onto a large CNC milling machine for final edge trim. Perimeter clamps and sandbags were used to hold the panel flat against the machine bed, as shown in Figure 6-31. Solid carbide rotary bits and small-diameter abrasive cutoff wheels were used to produce the detailed features in the periphery of the skin and scalloped profile of the cap web, as shown in Figure 6-32. Large access door openings were also cut out of the upper and lower bulkhead panels. Finally, pilot holes were drilled into each panel at discrete locations to support the Determinate Assembly (DA) approach being used for the MBB. The net-trimmed panels were then shipped to the Boeing C-17 facility in Long Beach, California, where assembly of the MBB was performed.

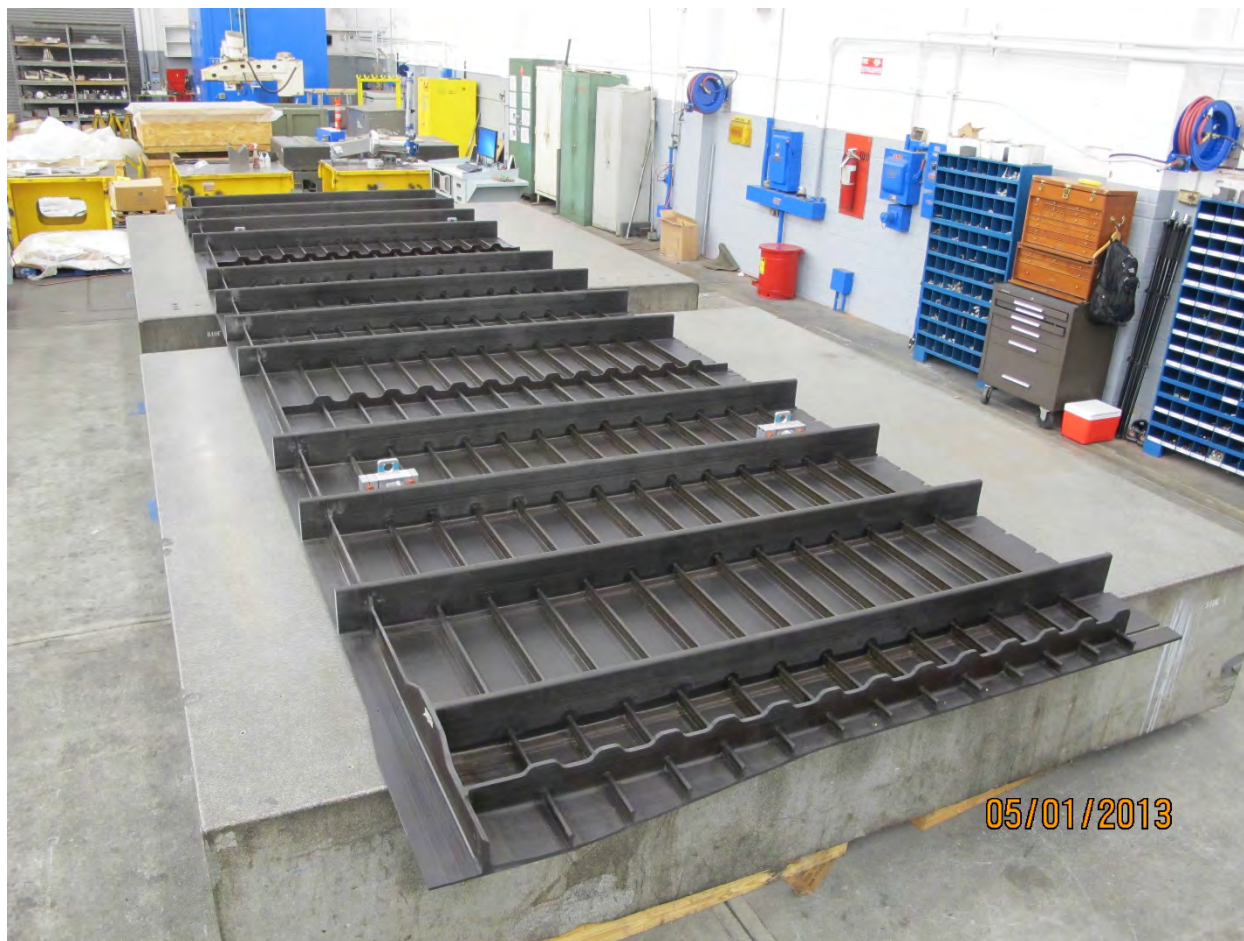
**Figure 6-33. Upper Bulkhead Panel Positioned on Surface Table for Final Dimensional Inspection**

A full dimensional inspection of the trim was performed on each panel before and after machining. The panels were placed on top of two large surface tables with the IML surface facing up (Figure 6-33). With the panel restrained, measurements were taken off the IML surface using a laser tracker. Inspection data was then compared against the CAD models to evaluate the machined surfaces and DA hole locations.

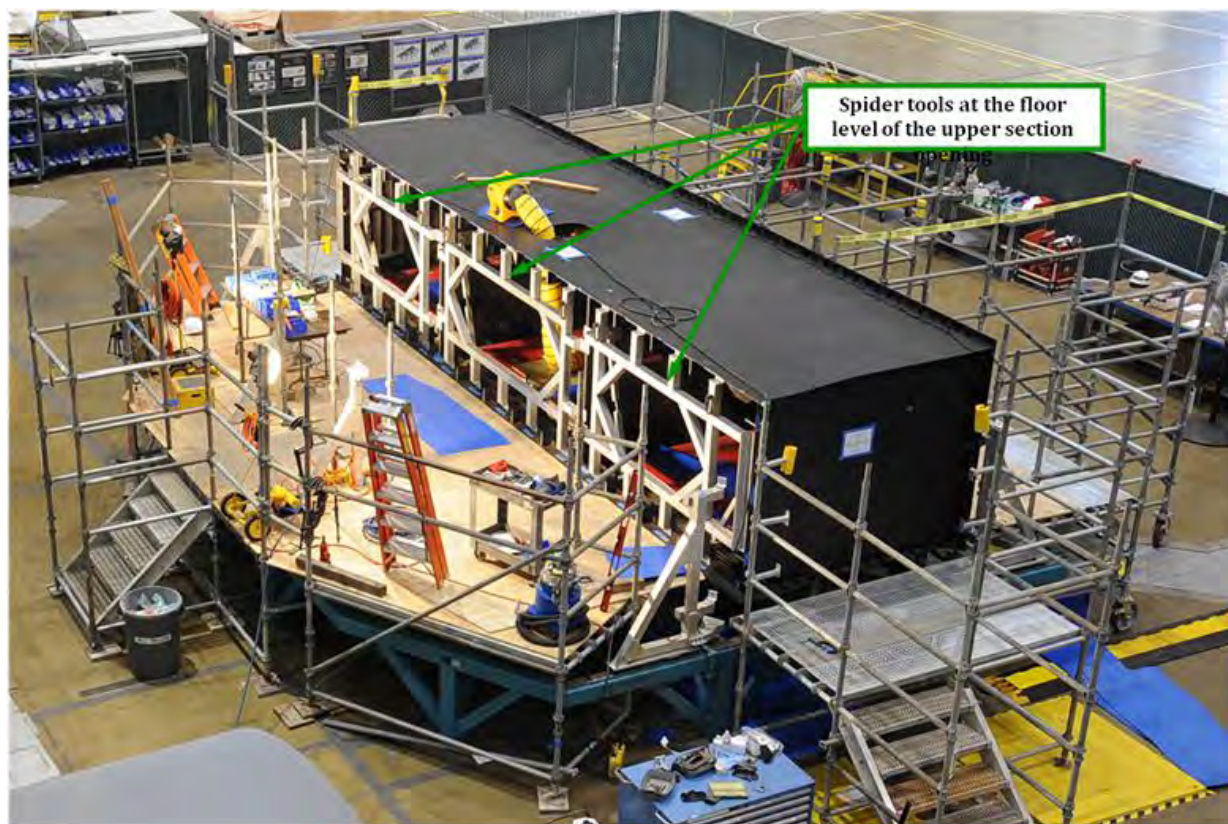
**Figure 6-39. Upper Section With Spider Tools at the Floor Line of the MBB**

Once the upper section was squared and plumb, the first holes were drilled to locate and install the spider tool weldment at the floor level of the box, as shown in Figure 6-39.

These spider tools enabled safe entry into the upper section of the box to work details and maintain the box opening rigid until the upper section panel-to-panel fasteners and metal fittings were installed.

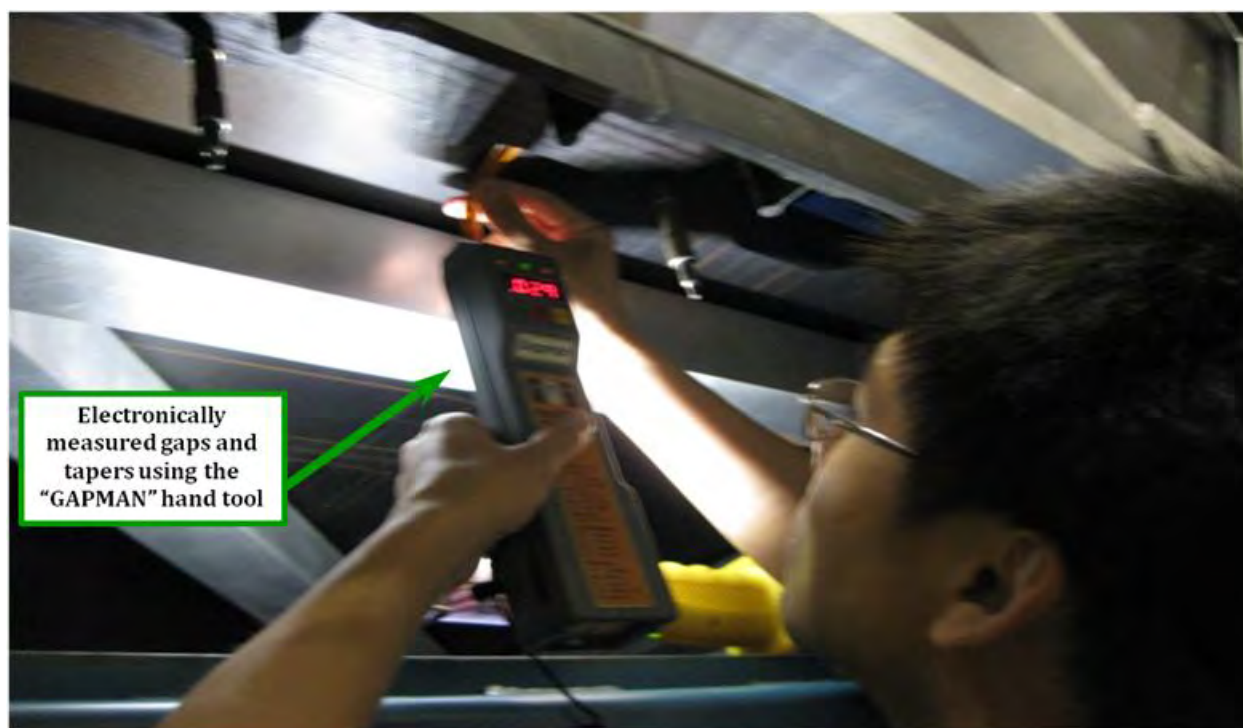
**Figure 6-41. Using the GAPMAN Device to Measure Gaps and Tapers**

Use of the GAPMAN hand-held measuring device was essential to determine the approximate tapers and contours of the shims that filled the gaps, especially at the crown panel to upper bulkhead cap interfaces and the end rib to upper bulkhead cap interfaces (Figure 6-41).

All gap readings were conducted while the panels were in position and pinned with clecos or temporary fasteners utilizing the DA holes only. Panels were not preloaded and were held in a relaxed state for measuring gaps with the GAPMAN device. Shims were fabricated at the C-17 quick-fix shop in Huntington Beach in accordance with the Unigraphics solid models that define the outer trimmed shape and the GAPMAN readings that define the thickness, as shown in Figure 6-42.

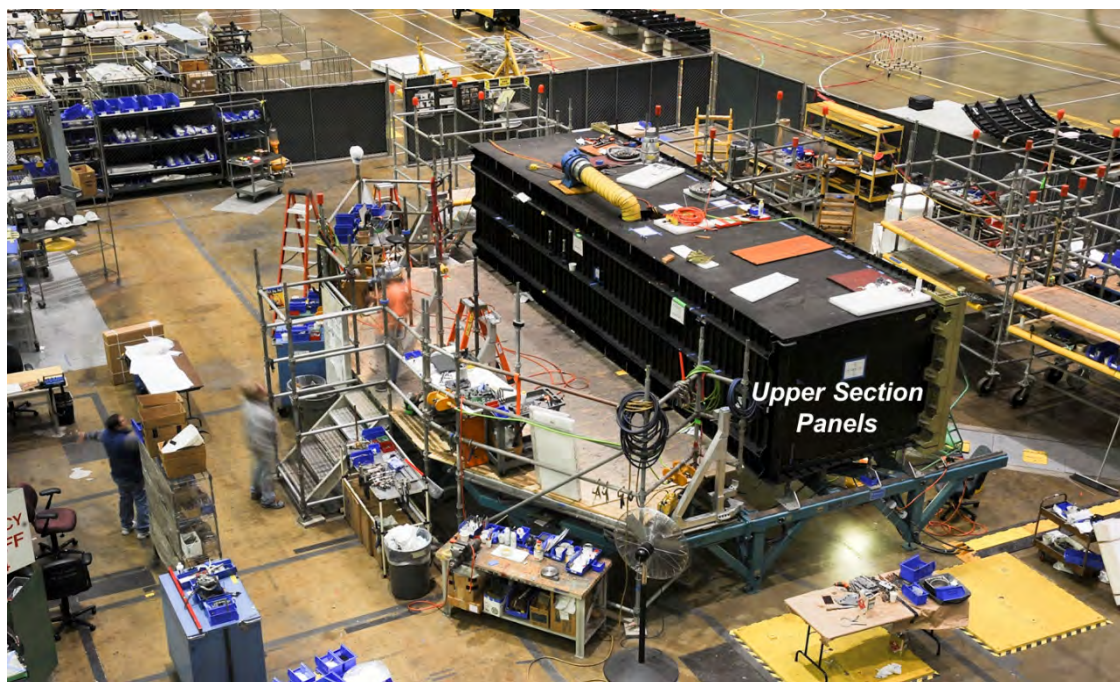
**Figure 6-46. Upper Section Panel Assembled With Floor Panel Installed**

After all upper fittings were installed, the floor panel was located and installed (Figure 6-46). Next, the lower section panels were installed except for the center keel panel (Figure 6-47), which facilitated installation of the lower section fitting. No panel-to-panel shims were required when assembling the lower section panels (Figure 6-48). This accelerated the hole-drilling and fastener installment operation because it eliminated the need for shims to be modeled, fabricated, and placed, as was done in the upper section.

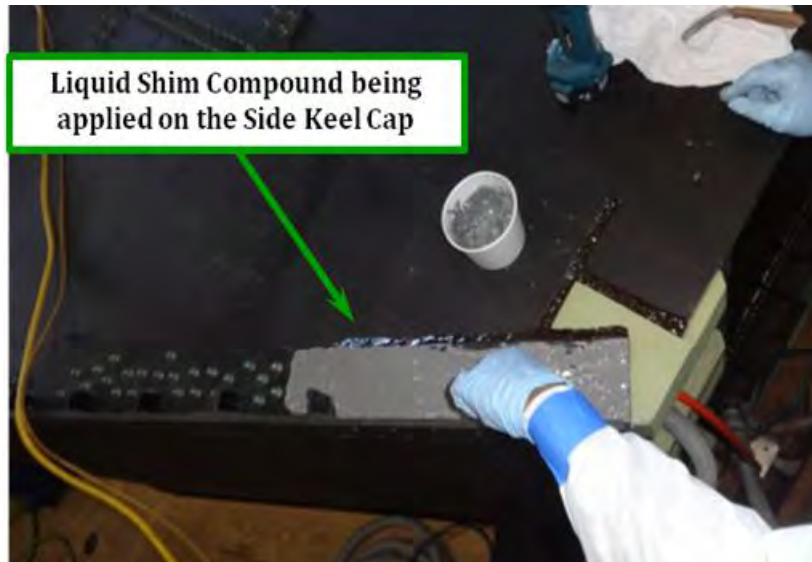
**Figure 6-53. Liquid Shim Application**

Because the fittings interfaced with wavy panel surfaces, proud stitching, and panel imperfections, the fittings were first coated with Frekote Mold Release material and installed with liquid shim material DPM5535-2 (EA934) or DPM5535-4 (EA9394). Should the fitting need to be removed for any reason, the Frekote would release from the liquid shim and prevent any damage occurring to the composite panel. Clecots and temporary fasteners were also coated with Frekote so that they could be easily removed and not be bonded in the pilot hole that was used to clamp and hold the fitting in place.

The liquid shim compound came in two-part cans. Because the working life after mixing the compounds was less than 30 min, all affected parts and surfaces had to be ready for liquid shim

application and part clamp-up into the structure. Figure 6-53 shows the application of the liquid shim compound.

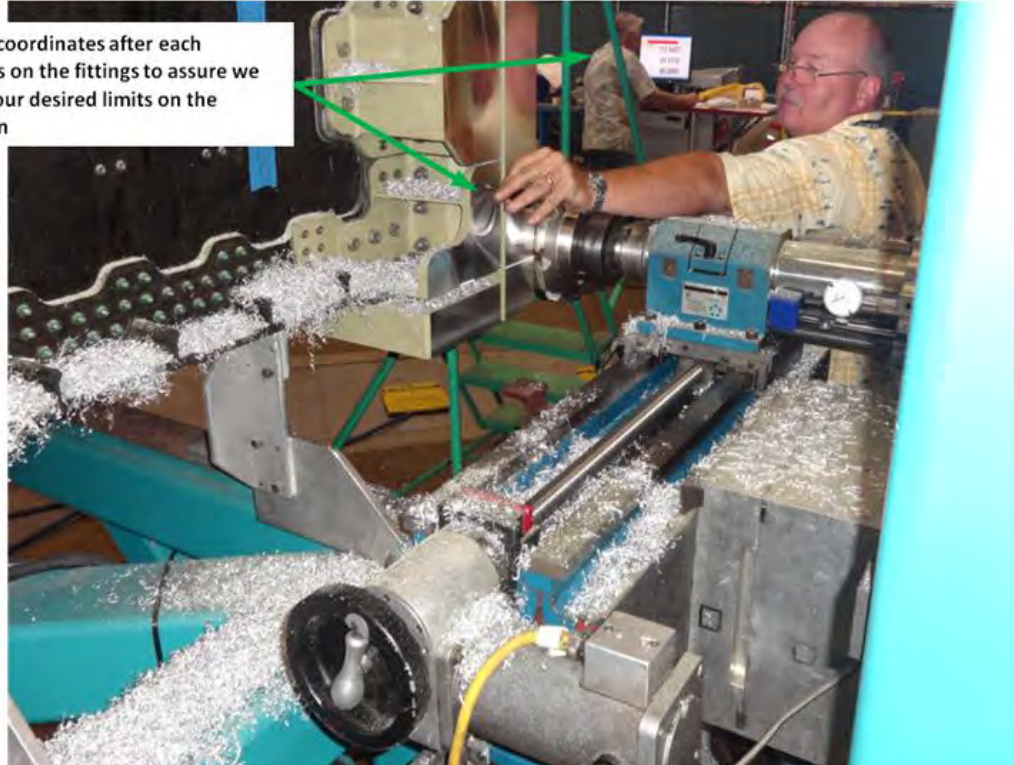
**Figure 6-61. Milling the Load-Introduction Fittings—Checking X, Y, and Z Coordinates**

Milling operations started on the upper right-hand corner fittings of the MBB. To eliminate any possible vibration and harmonics while cutting away material, milling was performed during the second shift and with no personnel inside the MBB assembly. After every pass of the cutter, spot checks were made and computed by tooling to ensure that the milling did not surpass the desired limits on the overall 30-ft, 0.120-in. span, as shown in Figure 6-61.

Checking x,y,z coordinates after each machining pass on the fittings to assure we don't surpass our desired limits on the overall 30' span

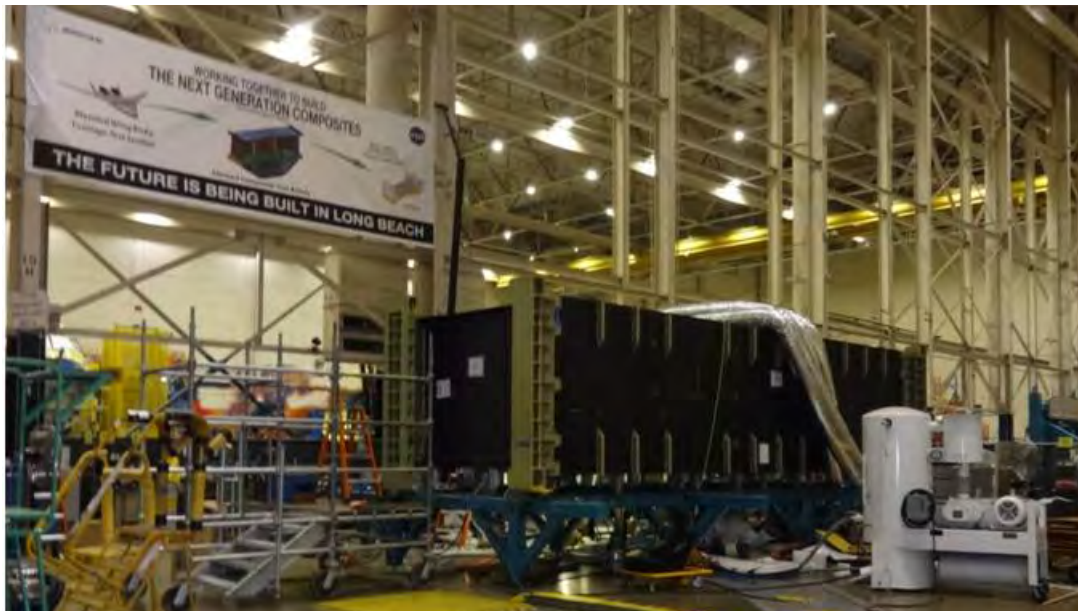
Figure 6-64. Starting Position of the Multi-bay Box

As shown in Figure 6-64, the MBB was assembled on its aft side. In this position, no additional assembly tools were required to build the test article. The highly integrated panels were stiff enough to maintain their shape, and once DA-pinned together, the MBB rectangular shape was very rigid. With the bulkhead panel on the bottom acting as the base, the other panels were simply pinned together. Conversely, in an upright position, assembly jigs would have been required to support in position both the panels and the technicians standing on them. The approach taken also made it easier to assemble the side keel panels in the lower section. (In an upright position, the technicians would have had to climb up the slopped sides, making assembly much harder.)

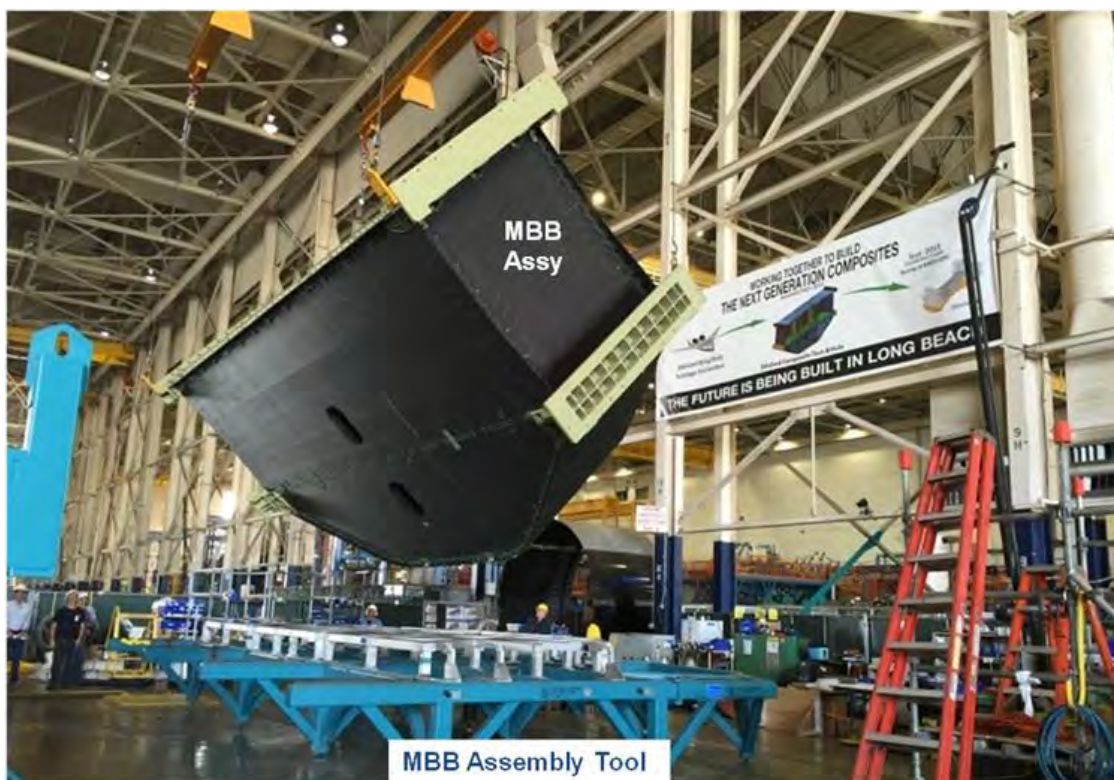
Figure 6-67. Rotation of the Multi-bay Box

The lift, rotation, and turning the MBB into its vertical position went as planned and with no incidents, as shown in Figure 6-67, Figure 6-68, and Figure 6-69.

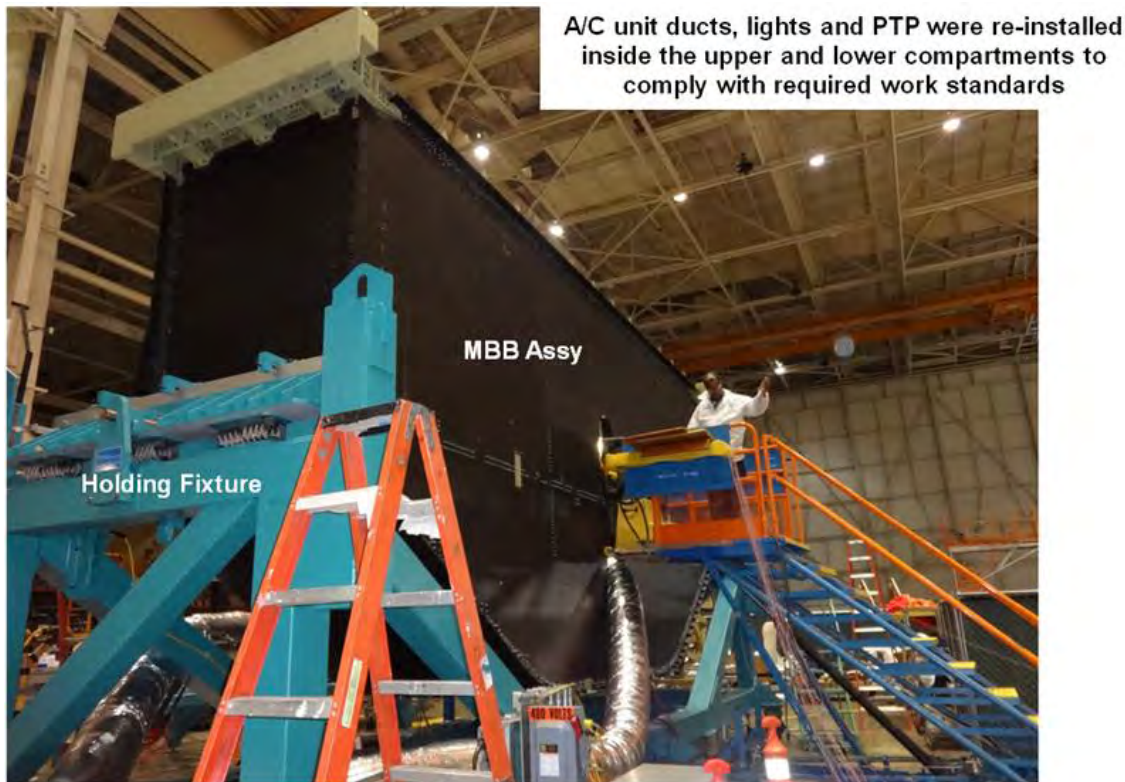
**Figure 6-70. Multi-bay Box Assembly on the Holding Fixture**

Once the MBB was set and locked in the holding fixture (Figure 6-70), preparations began to restart work in the upper and lower bays and complete the work needed that had been inaccessible in the aft bulkheads due to the beams in the assembly jig AJ1 tool.

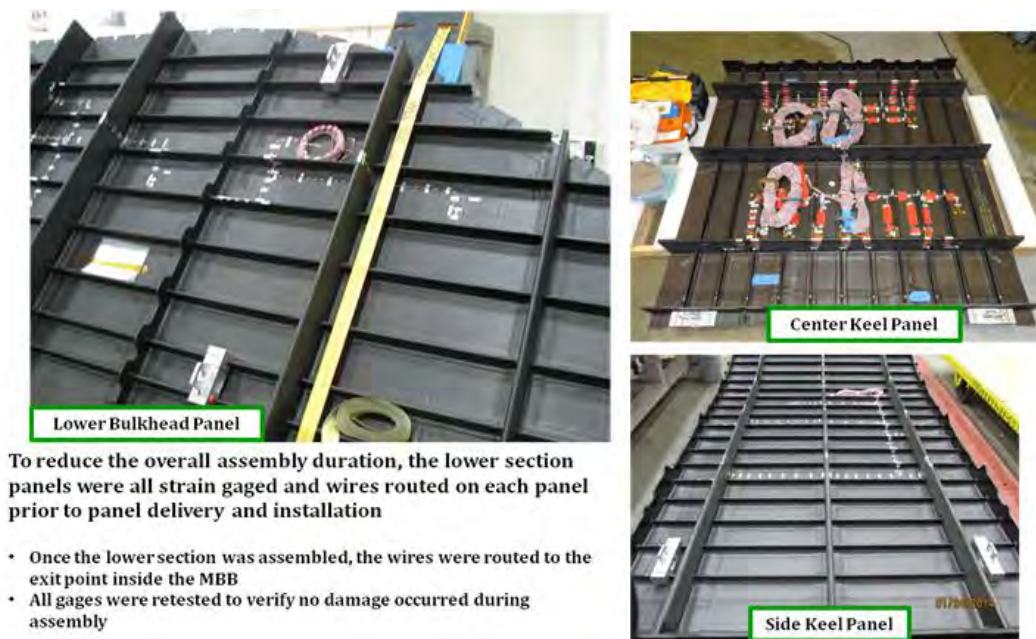
**Figure 6-72. Lower Panels Were Strain-Gaged Before Assembly**

Strain gages for the lower section panels had been installed at the Boeing Huntington Beach facility (Figure 6-72) before the panels were shipped for final assembly in Long Beach, which helped reduce the overall MBB assembly duration.

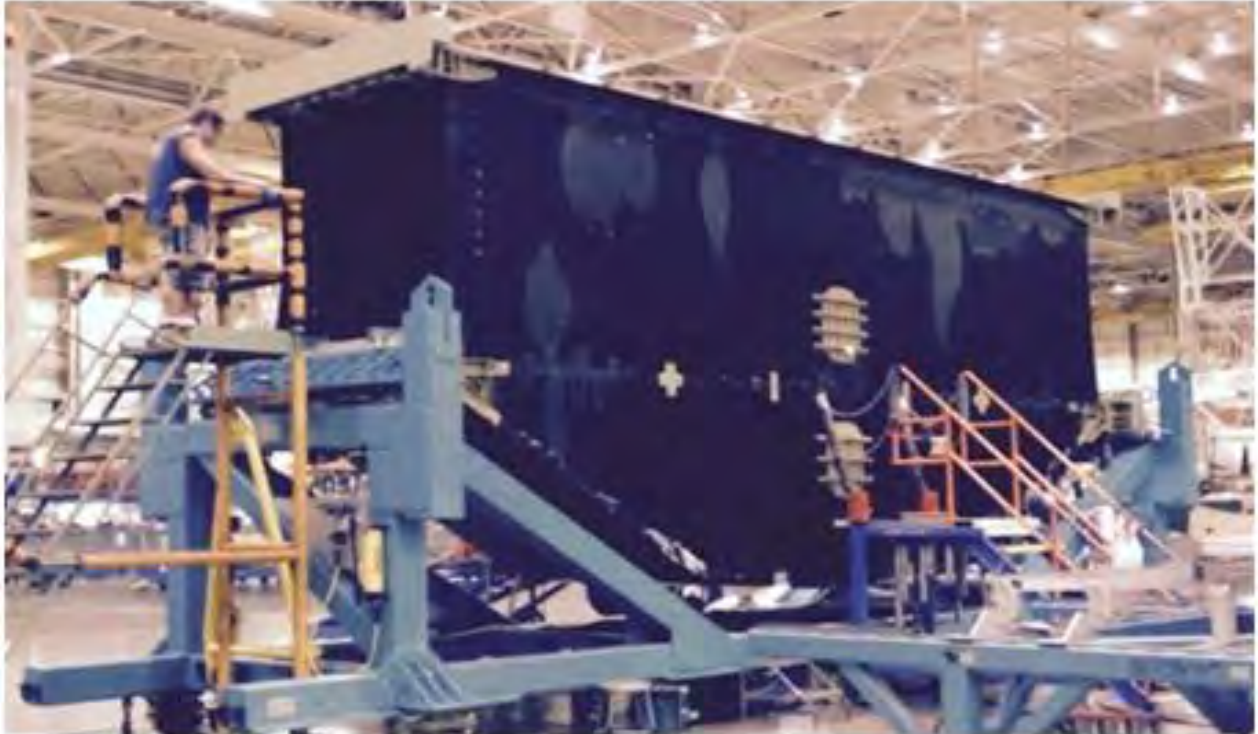
**Figure 6-75. MBB Leak Check at 6 psi Using Soapy Water to Detect Leaks**

The 6-psi pressure test was conducted on the MBB at the Long Beach facility before delivery to NASA (Figure 6-75). Soapy water was used to enable detection of any air leaks in the structure. In Figure 6-75, the soapy water is shown running down the bulkhead surface after being sprayed along the crown panel cap joint at the top of the panel. Finding the actual source of air leaks was challenging, however, because only two of the four methods to seal the MBB had been used. Without the faying surface in the panel-to-panel joints, air was free to travel along the joint.

Figure 6-75 shows the soapy water bubbling up along the lower bulkhead to side keel joint. Once leak areas were marked for inspection, the forward face access doors were removed so that mechanics could reenter the MBB and reseal the leaks. To help determine actual leak sites, air was blown from the outside in (Figure 6-76) while mechanics sprayed soapy water along the joints on the inside Figure 6-77. The leaks for the bubbles shown in Figure 6-76 were two small pin holes. A similar situation occurred along the upper cap. Figure 6-78 shows an internal view of the leaky joint that had three small pin holes, both before and after the area was resealed. Any air leaks that were found were resealed with the same PR1422 sealant material that was used to fillet seal and encapsulate the fasteners on the MBB.

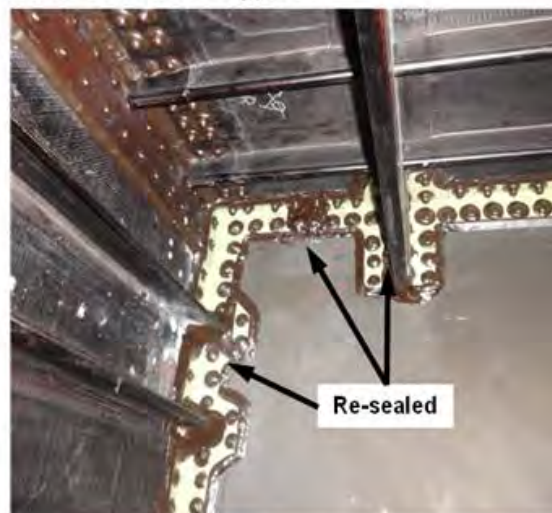
Figure 6-78. Typical Pressure Leaks, Checks, and Fixes

Typical fix once a pressure leak was found was to clean the surfaces to be re-sealed and then seal was re-applied

Upper Center Rib with leaks

Upper Center Rib after fixing the leak path

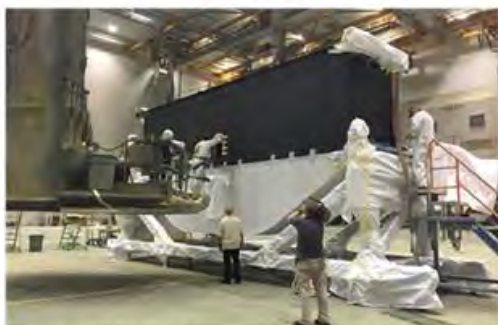
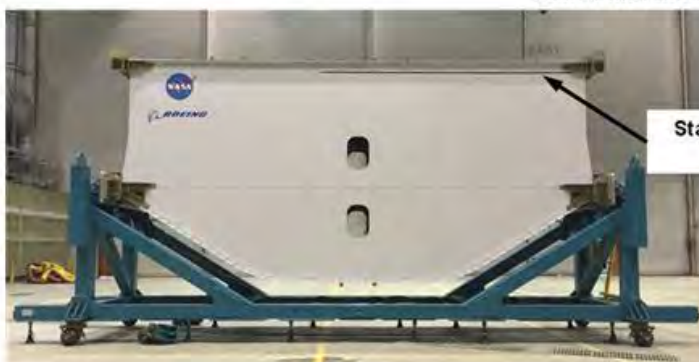
Figure 6-80. Painting the Multi-bay Box

All composite panels and interior metal fittings that held the structure were painted. However, the outside load-introduction fittings, adapter fittings, and the four access doors were not painted. Also not painted were some stay-out areas on the composite panels for the exterior instrumentation that NASA would install, as shown in Figure 6-80.

Painting the Lower section of the MBB

The interior of the MBB was hand painted with brushes. All inner mold line (IML) details were coated with white paint

Stay out area for the Fiber Optics

Because the composite material was a dark color, it would be difficult to see where delamination or ply separation would start and end during testing. Therefore, the MBB was painted a tone of white both inside and outside to enable effects on the material during and after testing to be more readily seen.

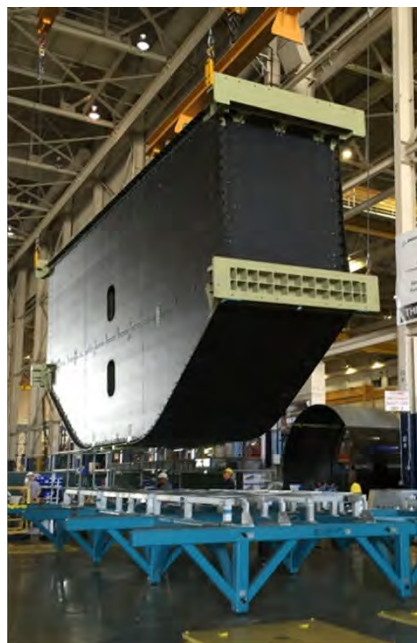
Figure 6-85. MBB Weight Based on 98% of the Assembly Being Completed

The MBB assembly was weighed when it was moved onto the handling fixture. At that time, the assembly was approximately 98% complete. Weight estimates were allocated to the items remaining to be installed, and they were added to the actual MBB weight to determine the final assembled MBB weight. Figure 6-85 shows the weight breakdown. By major component type, the weight breakdown is:

Actuals for 98% Plus to Go Work	
Fasteners (Estimate)	2 lbs
Sealant (Estimate)	12 lbs
Strain Gage Wire (Estimate)	2 lbs
Paint (Estimate)	66 lbs
Aluminum Fittings (Model Based)	64 lbs
Actuals	8,840 lbs
<b>Total Weight</b>	<b>8,986 lbs</b>

Vertical Weighing Position

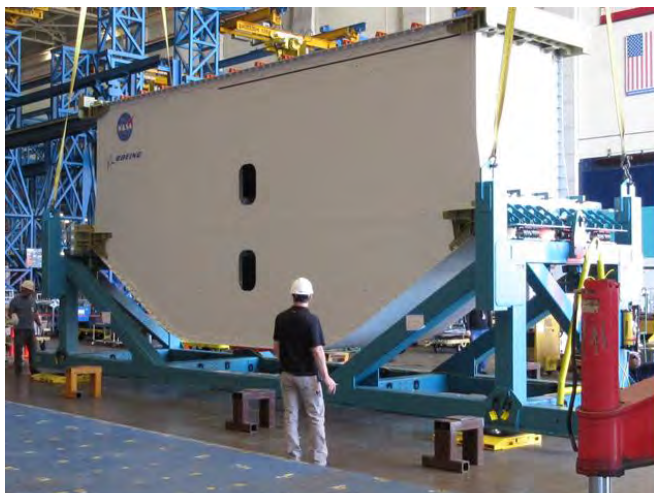
Figure 6-116. Combined Weight and CG Location Determined for X and Y Directions

Actual	Model*	Delta
Weight	23,741 lbs	23,955 lbs	214 lbs
X <sub>Pallet</sub>	283.00 in	286.73 in	-3.73 in
Y <sub>Pallet</sub>	0.78 in	1.12 in	-0.33 in
Z <sub>Pallet</sub>		77.96 in	-----

A final combined X axis and Y axis CG positions along with a final weight were taken during the installation of the fixture onto the Super Guppy pallet. Scales were located at the four corners of the fixture (Figure 6-116). Based on the weight and exact scale location, the final CG and weight were calculated and given to the Super Guppy team to determine the final pallet location. In preparation for shipping, the fixture was loaded onto the pallet prior to the arrival of the aircraft (Figure 6-117), and the tiedown bolts were installed at the 20 locations. Each flanged bushing was shimmed to maintain a 0.002- to 0.50-in. gap between the flange bushing and the foot of the fixture (Figure 6-118). This ensured that the pallet could grow and shrink during the flight due to temperatures swings in the cargo bay of the aircraft and not bind up. Once the pallet was loaded into the floor track system of the aircraft, the shims were readjusted to account for the uneven floor tracks. Any gap between the foot of the fixture and the pallet was also shimmed out using simple sheet stock.

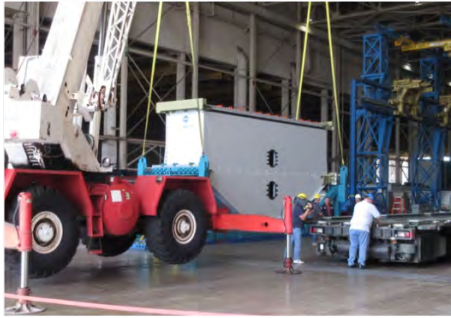
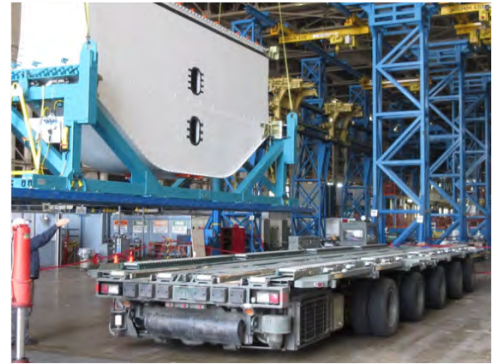
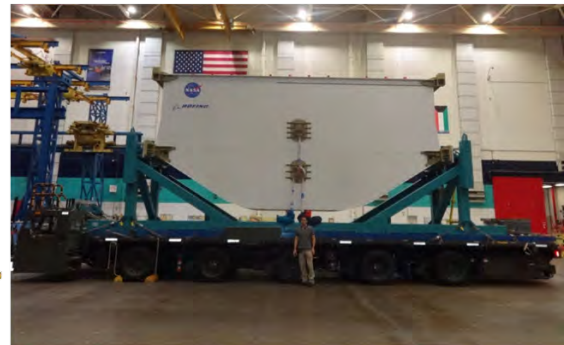
Figure 6-121. Loading the MBB on the K-Loader for Loading Onto the Super Guppy

Two (one overhead and one mobile) cranes were used to load the MBB on the K-loader.

Once loaded, the fixture was chained to the pallet and the pallet was chained to the K-Loader.

56 chains for the MBB and 6 chains for the wheels were used for fwd and aft restraint.

The fixture (with the pallet attached) was loaded onto a K-Loader using two cranes, one overhead and one mobile, and it was secured to the K-Loader using eight chains. Then all 56 chains that secured the fixture to the pallet were installed (Figure 6-121). The Super Guppy arrived at the Boeing Long Beach facility and was parked on the C-17 flight ramp (Figure 6-122). Preparations were made to the aircraft for loading the MBB, and once the forward supports were lowered, the nose of the aircraft was opened. The K-Loader transported the MBB to the aircraft and raised it to align with the aircraft cargo track system (Figure 6-123 and Figure 6-

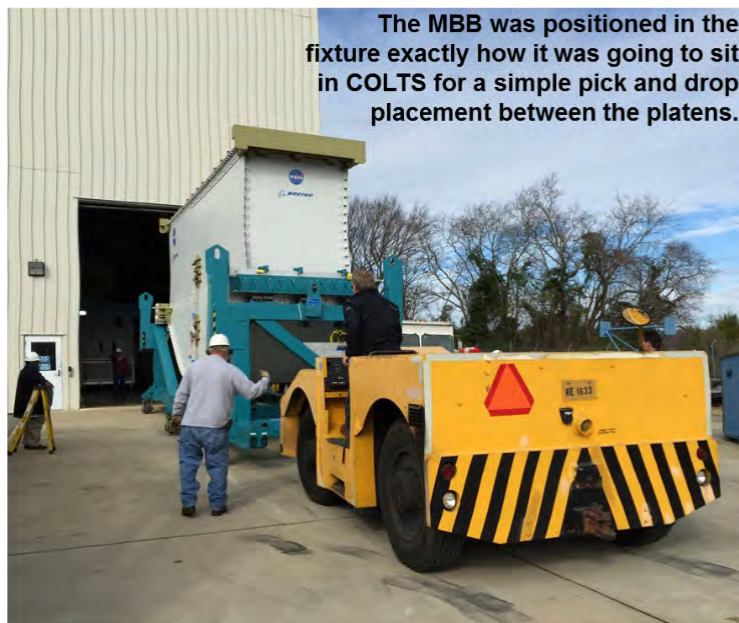
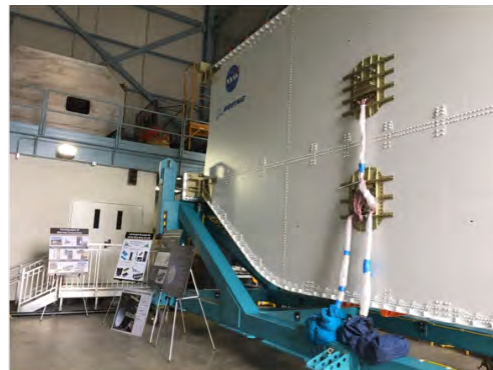
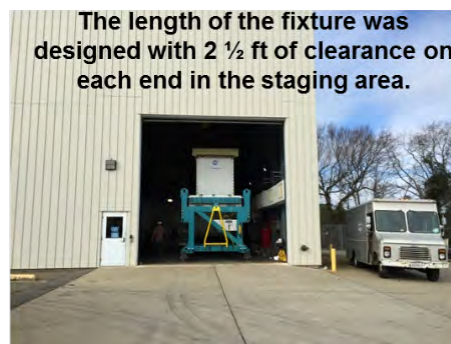
Figure 6-131. MBB Pushed Into COLTS Staging Area

The low profile fixture design allows ample clearance under the top of the roll up door.

The MBB was positioned in the fixture exactly how it was going to sit in COLTS for a simple pick and drop placement between the platens.

The length of the fixture was designed with 2 1/2 ft of clearance on each end in the staging area.

Thirty hours after the Super Guppy took off from Long Beach, it touched down in Hampton at NASA LaRC. The next day, the MBB was unloaded (Figure 6-130) onto a K-Loader. Alignment scribe lines that were marked on the fixture and pallet in Long Beach were checked to determine if the fixture had moved relative to the pallet. The lines were still perfectly aligned, indicating that the fixture had not moved during shipping. The K-Loader was driven to the COLTS facility where the MBB was unloaded. After the wheel assemblies were installed onto the fixture, the fixture was then pushed into the COLTS staging area (Figure 6-131).

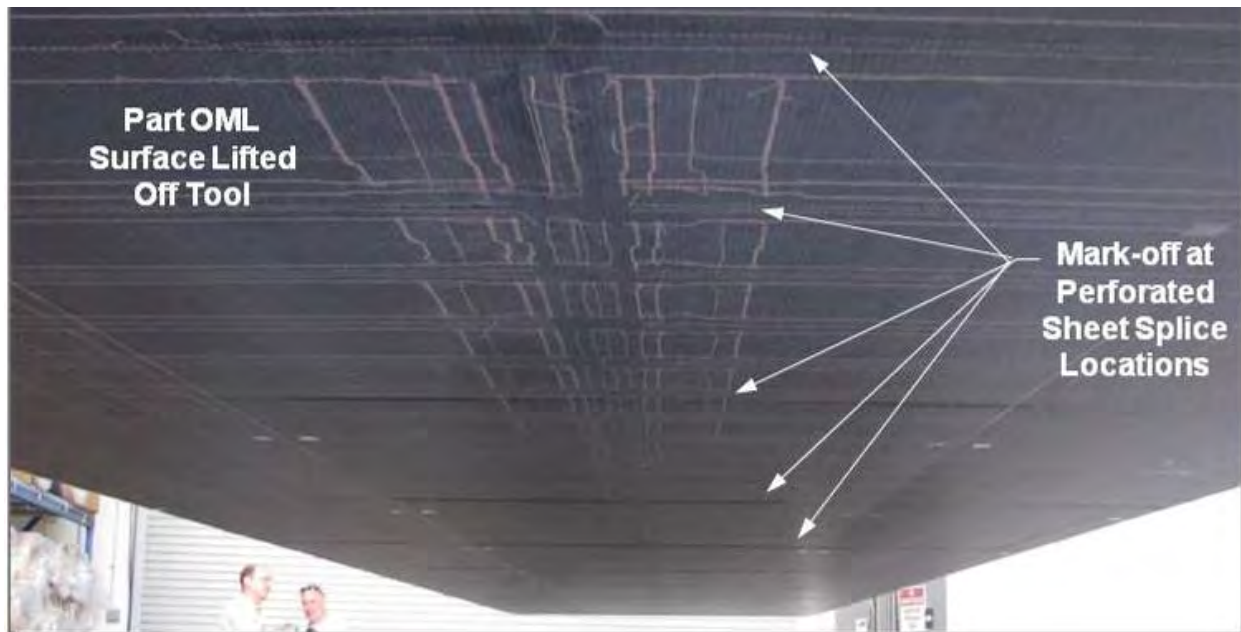
Unlike the tooling used for prior PRSEUS panel infusions, this was the first time an Invar cure tool was used. With panels almost 30 ft long, the mismatch in thermal growth between a steel cure tool and a carbon-fiber part would have created out-of-tolerance panels. During fabrication of the crown panel, a mark-off pattern occurred on the OML surface of the part during the infusion and cure cycle. This was caused by the edges of the perforated caul sheets that were placed between the preform and cure tool. Driven by thermal expansion, the sheets pressed together and then dug into the preform during the cure cycle, molding a permanent groove in the OML surface of the part (Figure B-1). The relative locations and groove depths are depicted in Figure B-2.

Figure B-1. Thermal Expansion of Caul Sheets Caused Mark-off on the Crown Panel OML

Because the resulting pattern matched the edges of the individual caul sheets, it was quickly determined that the difference in thermal expansion between the low-carbon steel perforated sheets and the Invar cure tool caused the interference. In addition to the mark-off, permanently buckled regions occurred in the caul sheets themselves along the spliced edges. This indicated that the sheets had grown during the cure cycle and caused permanent deformations in the regions with the smallest gaps between the sheets (Figure B-3). On subsequent panel infusions, the problem was resolved by increasing the spacing between the caul sheets, which eliminated the at-temperature interference condition that led to the grooves in the first panel.

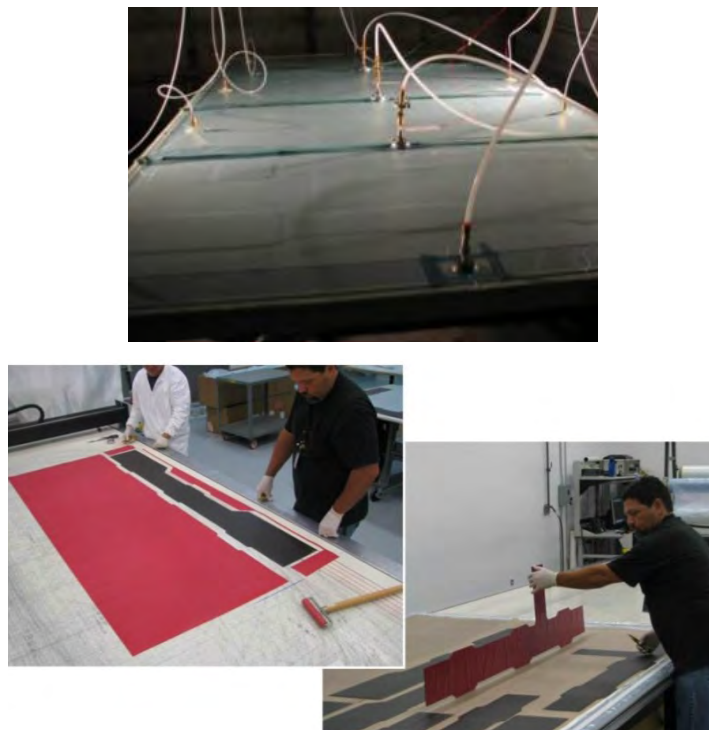
Once the patches were infused and cured in the oven, small bleed holes were mechanically drilled approximately 2 in. apart (to vent trapped air during bonding), and then an FM-209 film adhesive was applied to the back side of the patch (Figure B-9).

**Figure B-9. Patches Were Infused and Cured in an Oven and then Secondarily Bonded**

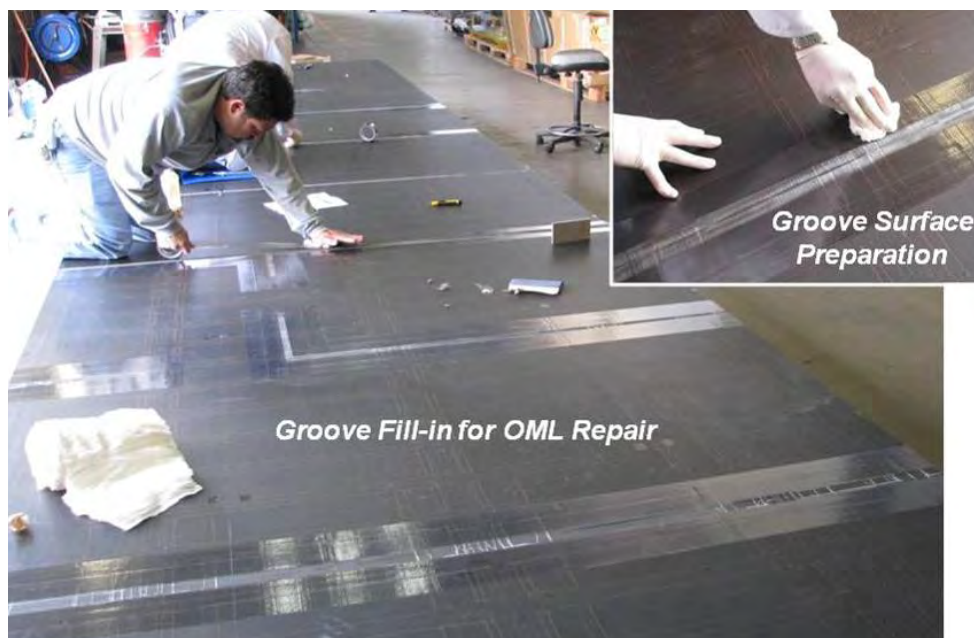
Simultaneously, the crown panel OML surface was being prepared by filling in the grooves, sanding them flush, grit-blasting the bonding regions, and then conducting water-break tests to verify the prepared surface condition (Figure B-10 and Figure B-11).

**Figure B-10. Crown Panel OML Surface Prepared for Repair**

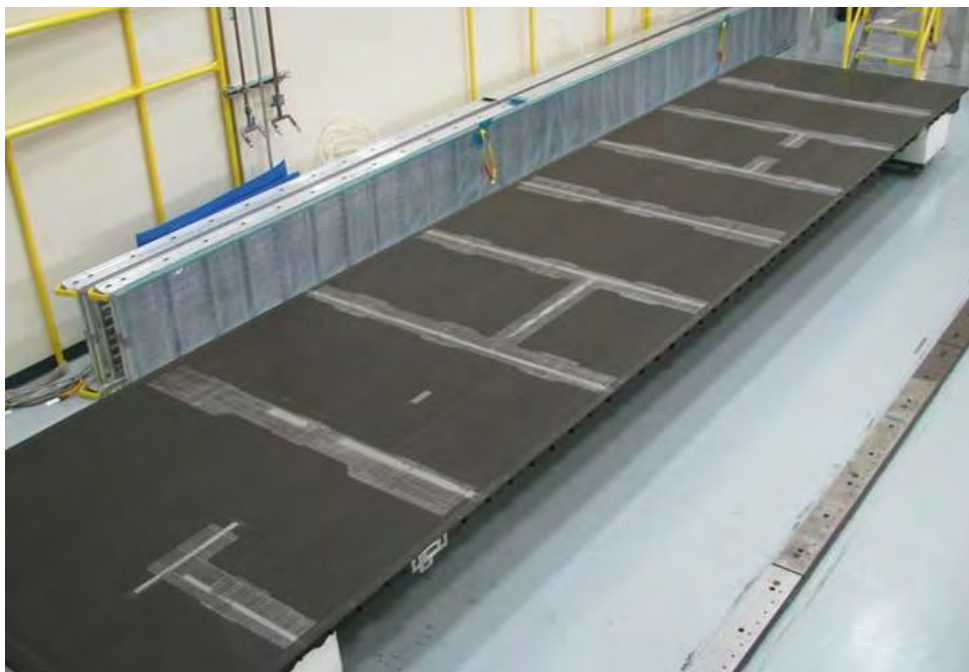
**Figure B-11. Bonding Surfaces Were Prepared for Repair Patches**

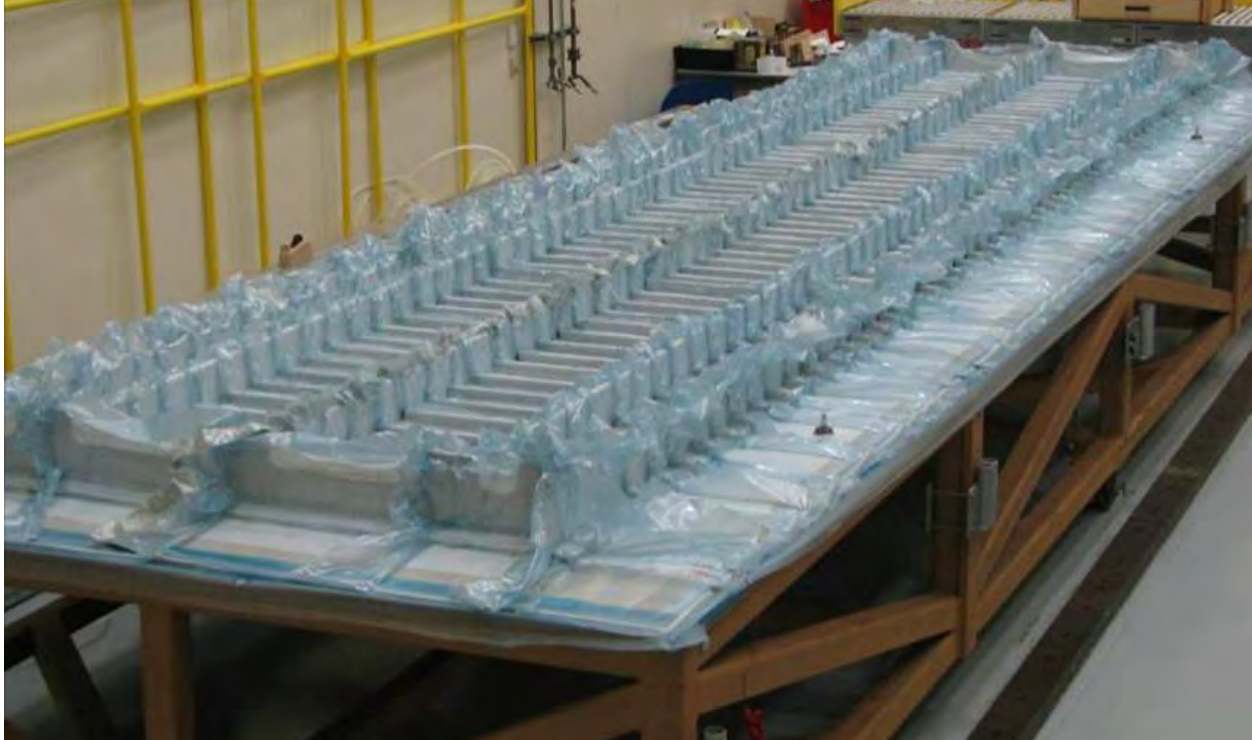
The prepared patches were then located into position, taped along the edges to secure them, and marked to aid in finding the bleed holes after the bonding cycle (Figure B-12). The panel was then flipped over onto the cure tool and vacuum bagged (Figure B-13).

**Figure B-13. Bagged Crown Panel With IML Side Facing Up and Repair Patches Taped to the OML**
